Date: 26th February 2025

TECH TOOL RELEASE NOTES

Version 2.8.310

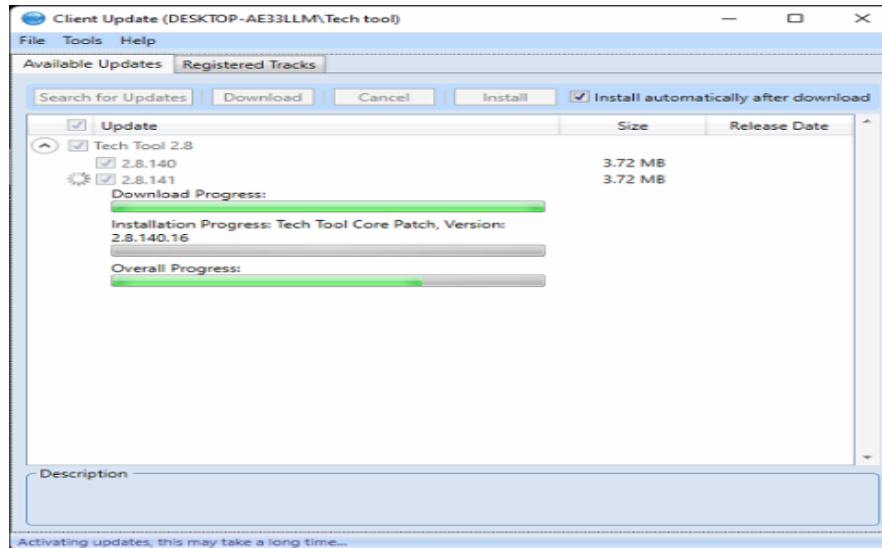
Issue-1: Tech Tool installation progress bar is frozen during Client Update.

Cause: Under Investigation.

Suggestion: Restart computer if the progress bar is frozen.

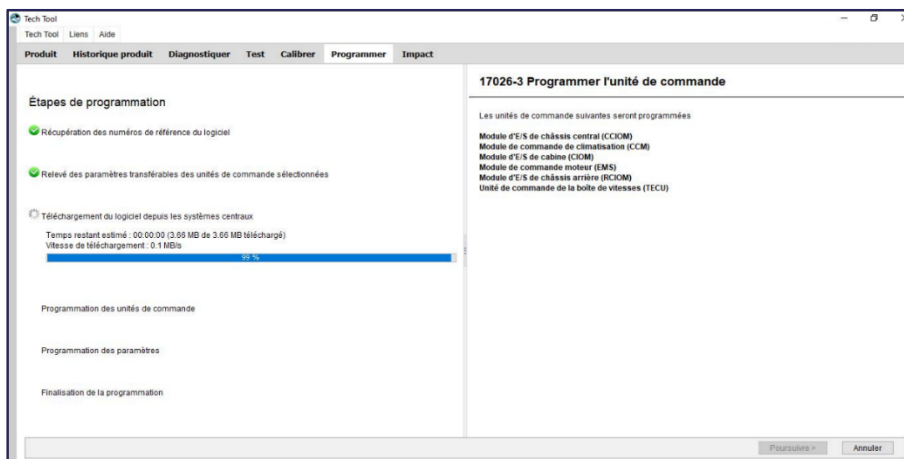
Issue-2: While programming, the software download might get stuck at 99%.

Cause: Under Investigation.

Suggestion: Use Quick Repair tool to resolve this issue. Refer [Video](#).

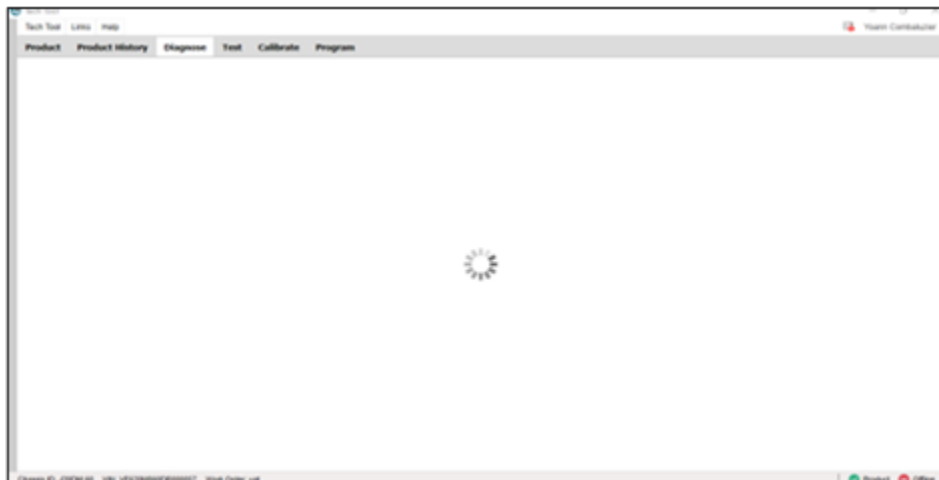
Issue-3: While switching between the tabs, Tech Tool might be frozen.

Cause: Under Investigation.

Suggestion: Kindly follow the below steps:

1. Ensure that there is a stable network as shown in the icon
2. Restart Tech Tool.
3. If not able to recover, restart the computer.

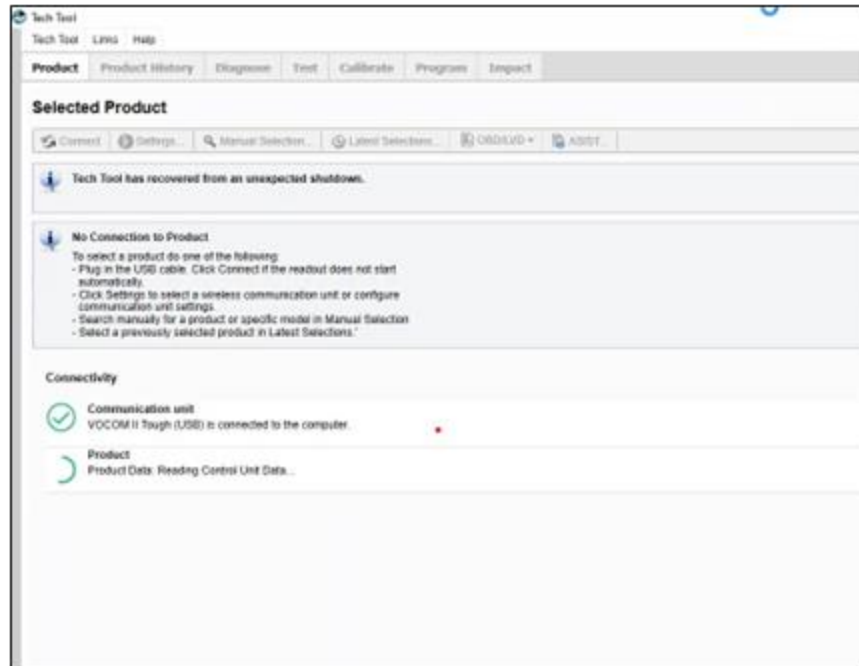
Issue-5: Product connection is taking time when connecting with non-Volvo adapter (Nexiq3)

Cause: Under Investigation.

Suggestion: NA

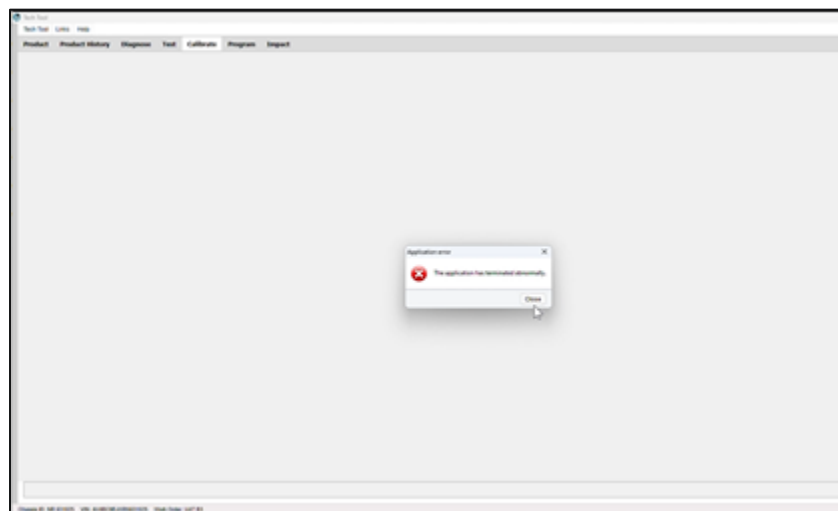
Issue-6: Tech Tool crashes when exiting Wireless gateway calibration

Cause: Under Investigation.

Suggestion: Using Tech Tool Log Manager, stop the BAF service to end the current work session. Restart Tech Tool.
