Date: 07<sup>th</sup> April 2025

# TECH TOOL RELEASE NOTES

Version 2.8.320

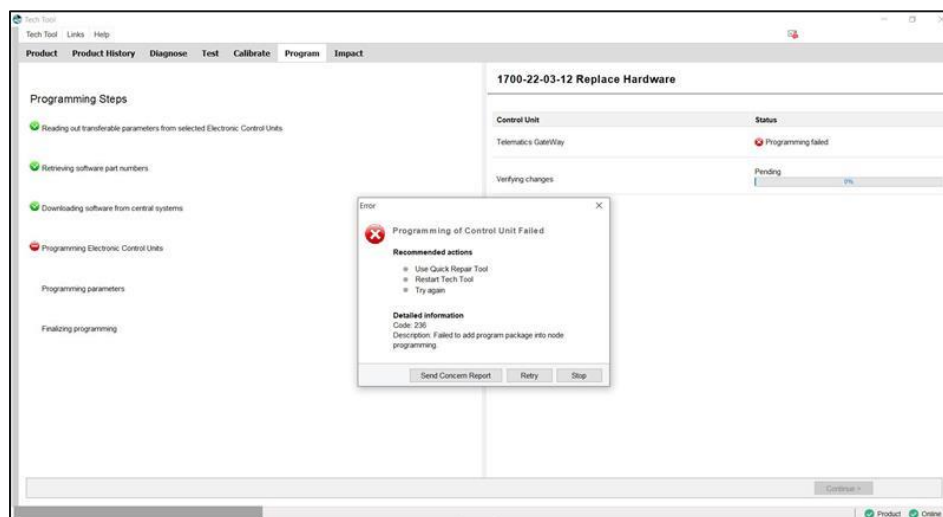
**Issue-7: Error 236 observed during the programming operation.****Cause:** Under Investigation.

**Suggestion:** Use Quick Repair tool to resolve this issue. Refer [Video](#).**Note:** For any issues & support, kindly use your normal channels.
