Date: 29 September 2025

TECH TOOL RELEASE NOTES

Version 2.8.350

Volvo Group

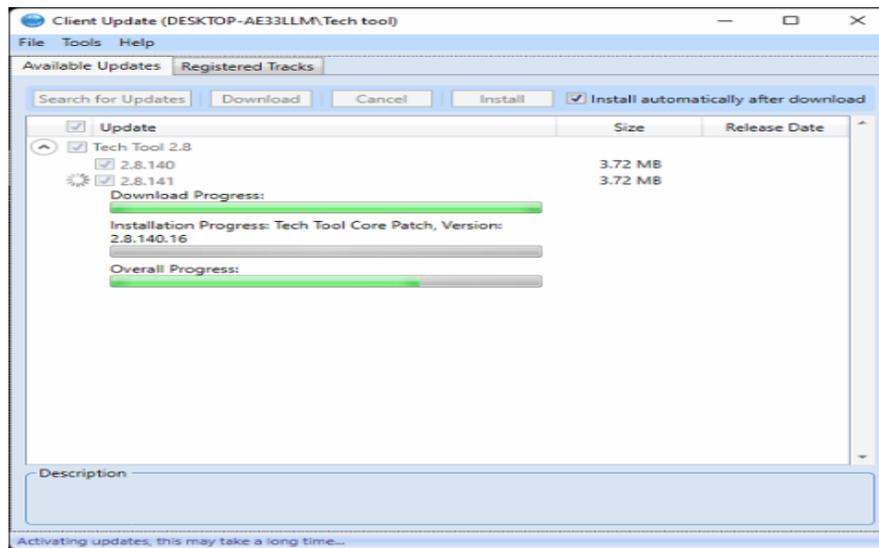
Issue-1: Tech Tool installation progress bar is frozen during Client Update.

Cause: Under Investigation.

Suggestion: Restart computer if the progress bar is frozen.

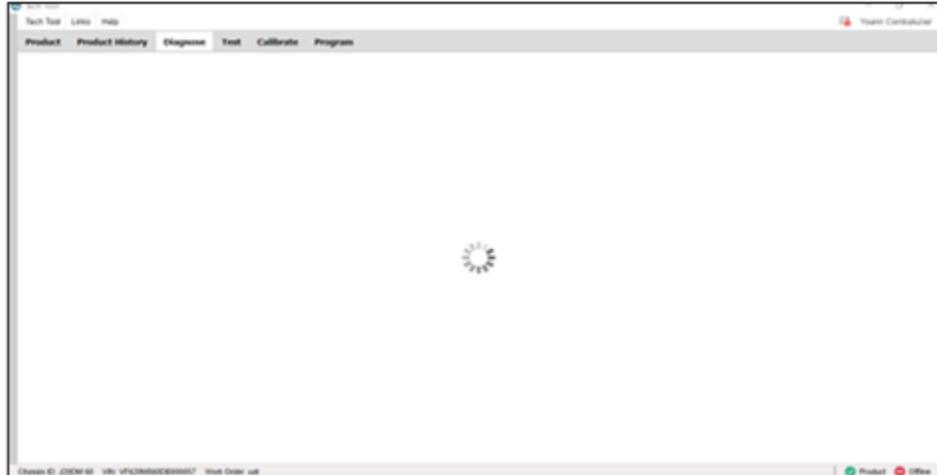
Issue-2: While switching between the tabs, Tech Tool might be frozen.

Cause: Under Investigation.

Suggestion: Kindly follow the below steps:

1. Ensure that there is a stable network as shown in the icon
2. Restart Tech Tool.
3. If not able to recover, restart the computer.
